INACTIVE AND ABANDONED MINE LANDS— Sierra Zinc Mine, Chewelah Mining District, Stevens County, Washington

WASHINGTON
DIVISION OF GEOLOGY
AND EARTH RESOURCES
Open File Report 2003-20
October 2003

Inactive and Abandoned Mine Lands— Sierra Zinc Mine, Chewelah Mining District, Stevens County, Washington

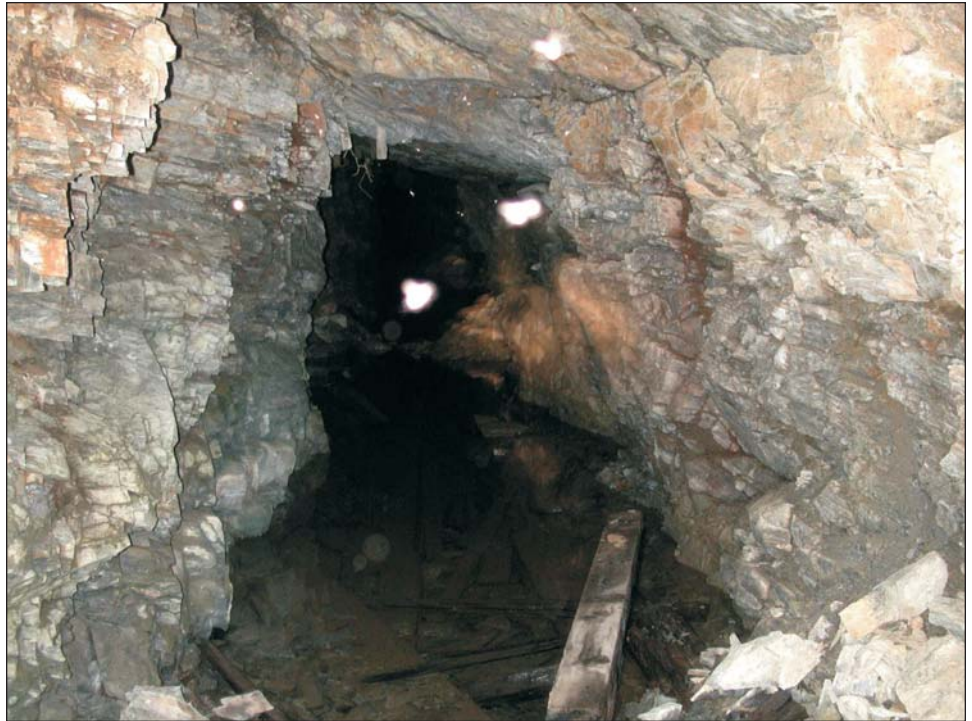
Figure 2. Main haulage tunnel, level 2 (lower) adit. Note standing water on floor.

We observed a 5-gallons/minute discharge from the level 2 adit that infiltrated the dump 50 feet from the portal. Drainage from internal workings had formed a pool approximately 12 inches

deep that extended inside the tunnel an unknown distance. A sample taken in September of 2001 had a conductivity of $970\ \mu\text{S}/\text{cm}$ and a pH of 7.0. A sample taken in June of 2002 had a conductivity of $530\ \mu\text{S}/\text{cm}$ and a pH of 5.7. Concentrations of the metals analyzed (As, Cd, Cu, Fe, Pb, Zn) indicate that the mine discharge meets the metals requirement for human consumption. The zinc content in one sample was slightly above the requirement for chronic affect to aquatic life (see Table 6).

Surface water migration: Water discharging from the haulage tunnel (level 2 adit) infiltrates 50 feet from the portal.

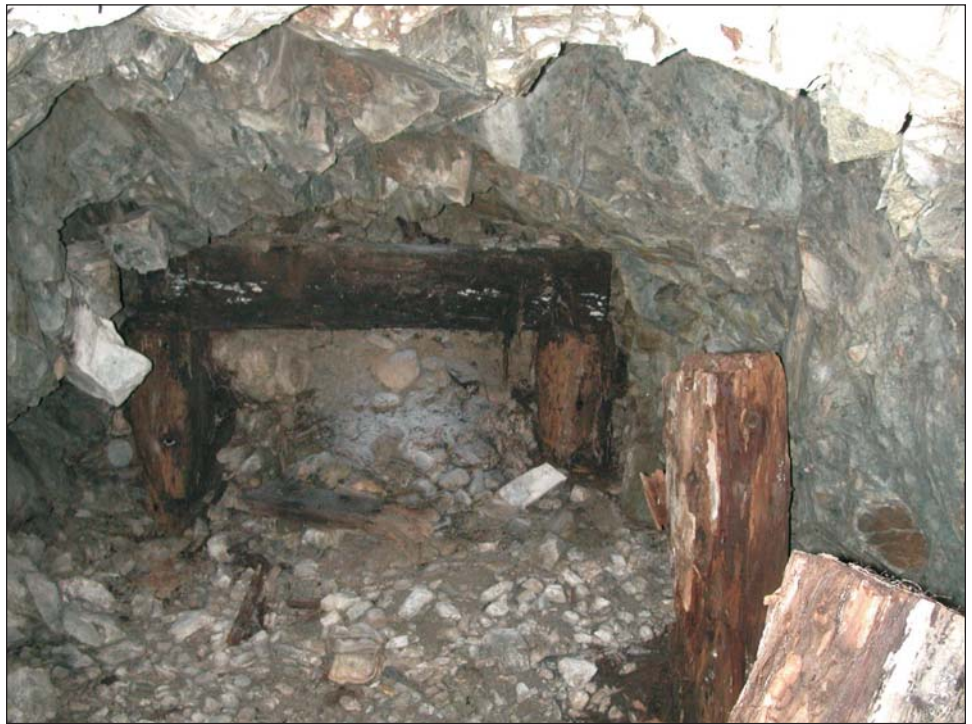
Figure 3. Level 1 (upper) adit.

adits drive horizontally almost due west into a low-lying ridge. Both openings intersected ore-bearing marble at a point 400 feet from the respective portals. Winzes follow the ore down dip from those intersections to levels 3 and 4. Campbell (1946) reported that stopes above the main haulage tunnel (level 2 adit) collapsed in 1945. DGER personnel located the haulage tunnel above a dump several hundred feet west of the mill. The portal was open but deteriorating, with 12 inches of water standing behind slough for an unknown distance (Fig. 2). According to a local resident, this opening was plugged for some time by a cave-in at the portal. In the spring of 1999, impounded water apparently shot across the dump, rolling 3-foot diameter boulders in the flow, which dissipated in energy and volume as it ran toward the mill (Ron Nixon, oral commun., 2002). Another adit (level 1) is located 100 feet higher than the level 2 adit and slightly to the north. The portal is open, but the cross section is caved about 20 feet inside. The original timber supports are soft and deteriorating (Fig. 3).

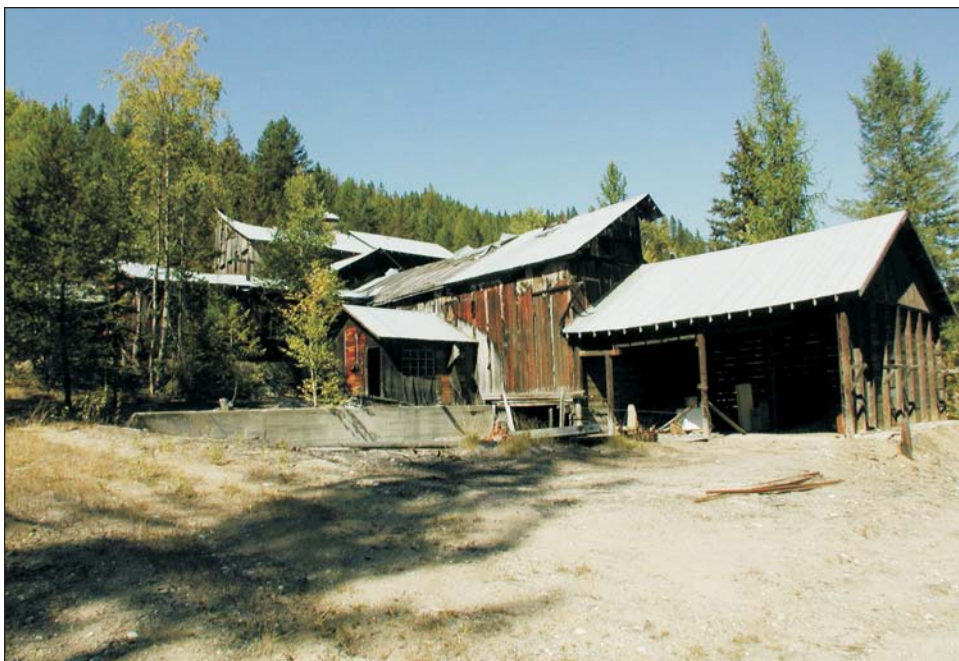
Figure 4. Mill building complex. View to the northwest.

The mill is a wood multi-tiered structure. Most of the original machinery was moved to the Schumaker mine in the 1960s. Areas with galvanized roofing still in place remain relatively stable (Fig. 4), however, other parts of the mill are deteriorating because various structural members have been taken for other uses (Fig. 5). The building should be considered hazardous. DGER personnel found six 55-gallon drums of miscellaneous petroleum products (labels unreadable), one drum of Aero 633 Depressant, and two drums of methyl isobutyl carbonic alcohol, also marked methyl amyl alcohol (Fig. 6). Private parties occupy several buildings constructed during previous mining activity.

Structures: The mill is badly deteriorated structurally. It appears that the mine office, bunkhouse, and cookhouse described in the *Mining World* (1943) article as part of the mining operation have been converted to residential use.

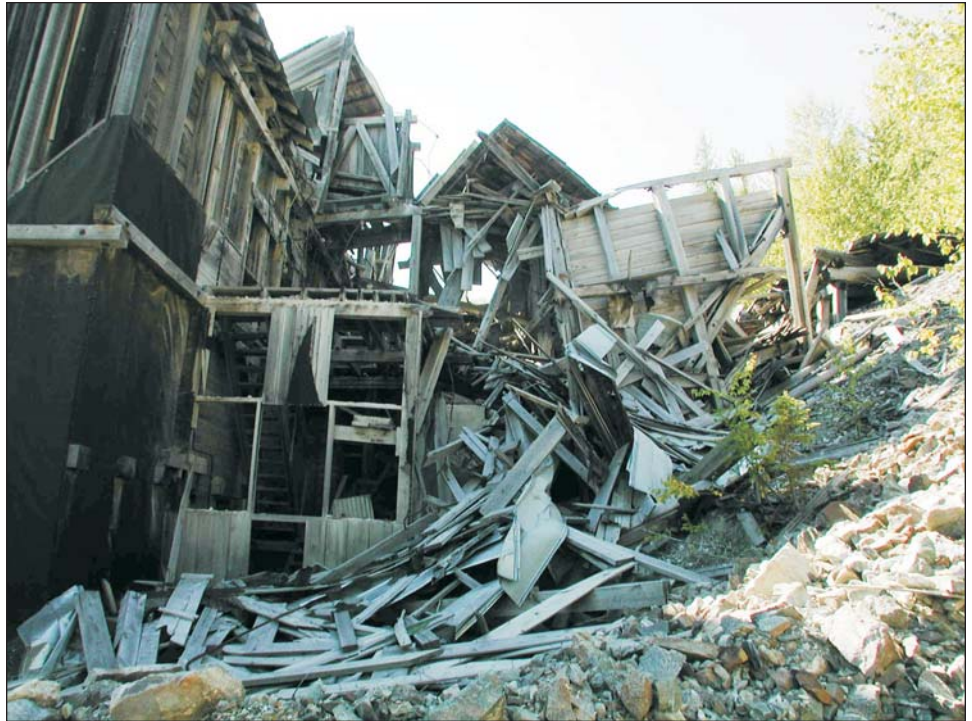
Figure 5. North side of the mill. View to the west.

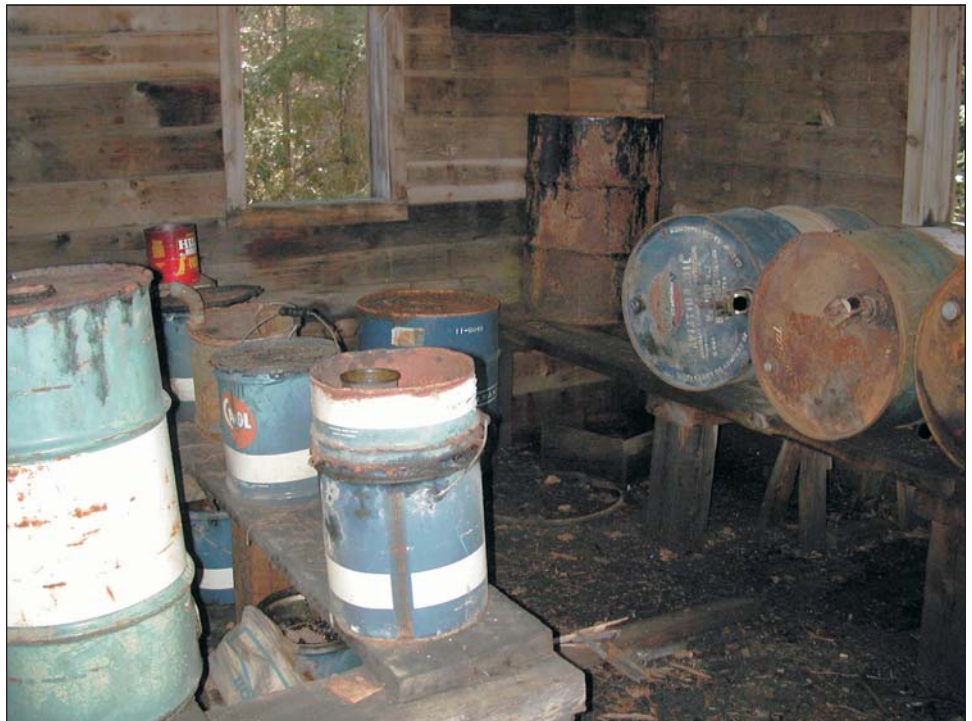
Figure 6. Containers of flotation reagents and lubricants stored in the old mill building.

Materials: two 50-gallon drums of methyl isobutyl carbonic (methyl amyl alcohol), one 50-gallon drum of Aero 633 Depressant, two 50-gallon drums of miscellaneous lubricants

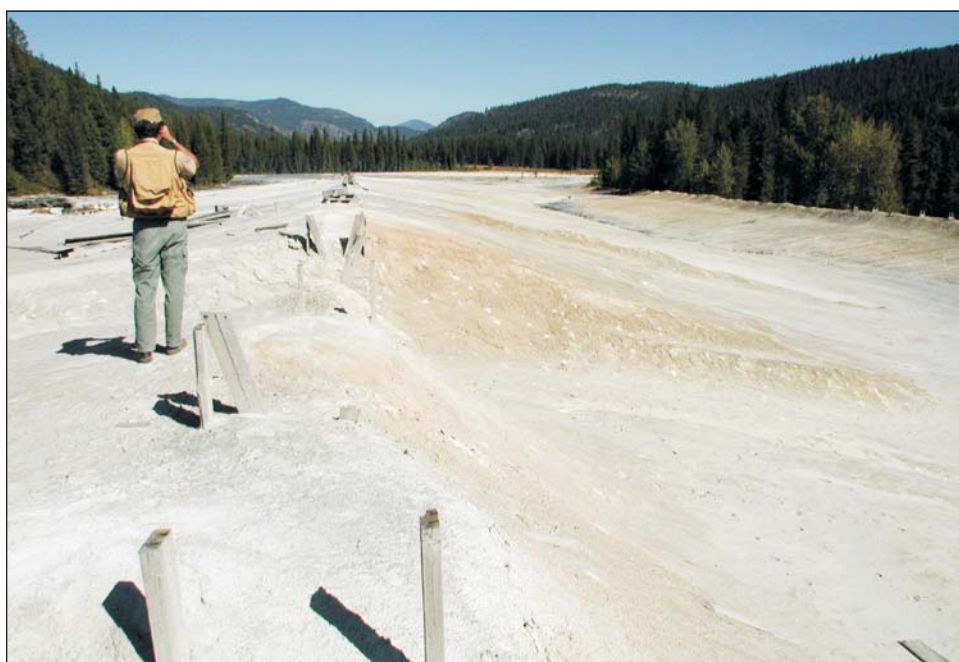
Figure 7. Mill tailings, approximately 0.5 miles in length. View to the north.

The major waste-rock dump in terms of volume is located adjacent to the portal of level 2. It contains an estimated 50,000 tons of unmineralized quartzite, schist, and marble. The tailings impoundment stretches northerly from the mine approximately one-half mile and spreads out to about 530 feet in width (Fig. 7). The total area measured from aerial photographs is 25 acres. The tailings closest to the mill are 12 to 15 feet high, tapering off to the north where the thickness is estimated at 2 to 3 feet. Most of the material is very light gray in color. However, a layer of distinct black tailings lying conformably on the lighter material was observed at the northwest corner (Figs. 8 and 9). Samples of both materials exceeded levels for lead, zinc and cadmium listed in Model Toxics Control Act for unrestricted land use (see Tables 3 and 4).

Waste-rock dumps, tailings, impoundments, highwalls, or pit walls: The waste-rock dump adjacent to the main haulage tunnel (level 2 adit) is 3- to 12-inch unmineralized shot rock. The tailings impoundment covers an area of 25 acres north of the mill and is approximately 2500 feet long by 530 feet wide. It

has a thickness of 12 to 15 feet near the mill and thins out to some unknown thickness at the northwest corner, estimated at 3 feet. As explained above, the tailings volume is considerably disproportionate to the amount of tonnage mined solely at the Sierra Zinc mine. Assuming from historical records that most of the 763,000 tons mined by Goldfield at the Deep Creek mine were processed through the Sierra mill, and adding 56,000 tons reported production from Sierra, a total of 819,000 tons were milled at the site (DGER mine file). With a mill recovery rate of 0.88 percent (Campbell, 1946), a material balance calculation puts the present tailings volume in the range of 500,000 to 606,000 cubic yards. The calculated average thickness is between 4 feet and 5 feet.

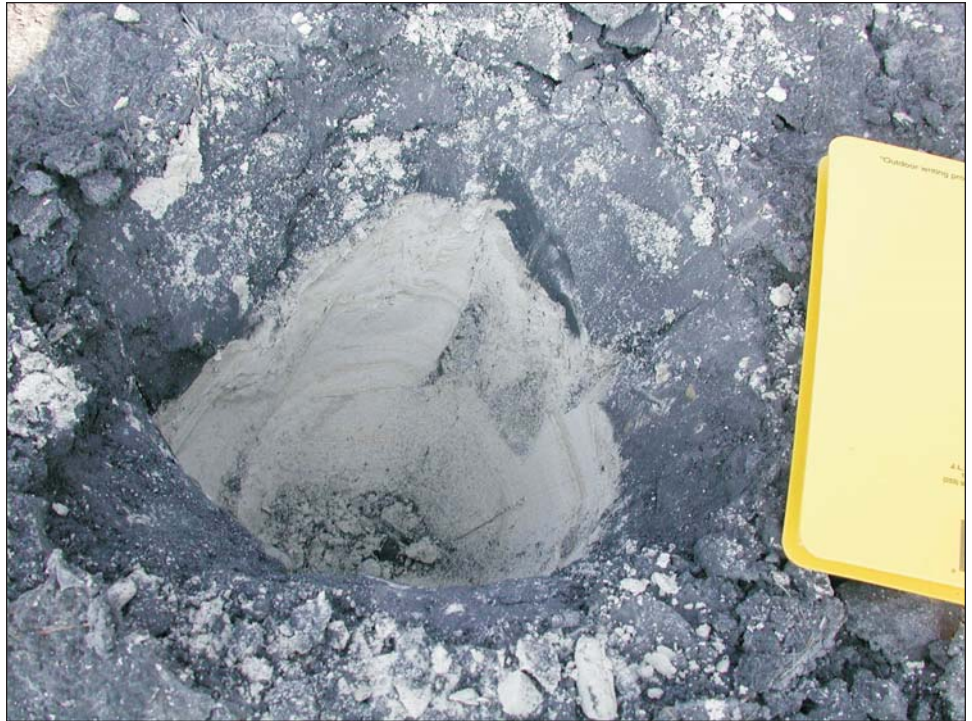
Figure 8. Dark gray tailings overlying light gray tailings. Eight-inch notebook for scale.

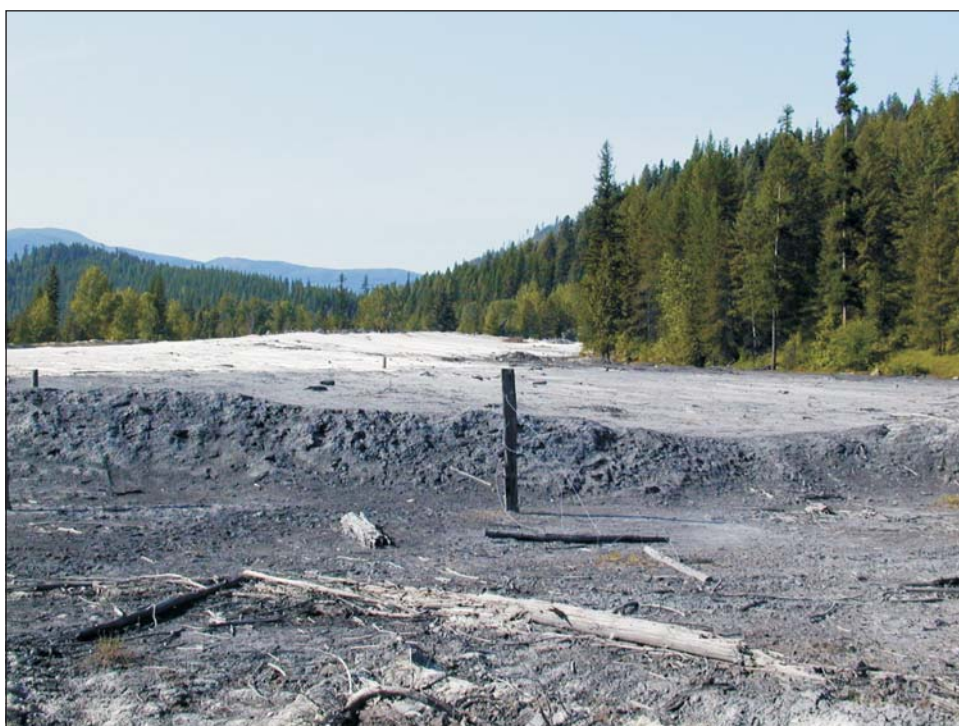
Figure 9. Dark gray tailings in the northwest corner of the tailings dump. View to the south.
